PETERLEE TOWN COUNCIL

Date: **A MEETING OF THE PARKS & CEMETERY COMMITTEE**

Site Management plan for Yoden Village Quarry- a geological Site of Special Scientific Interest

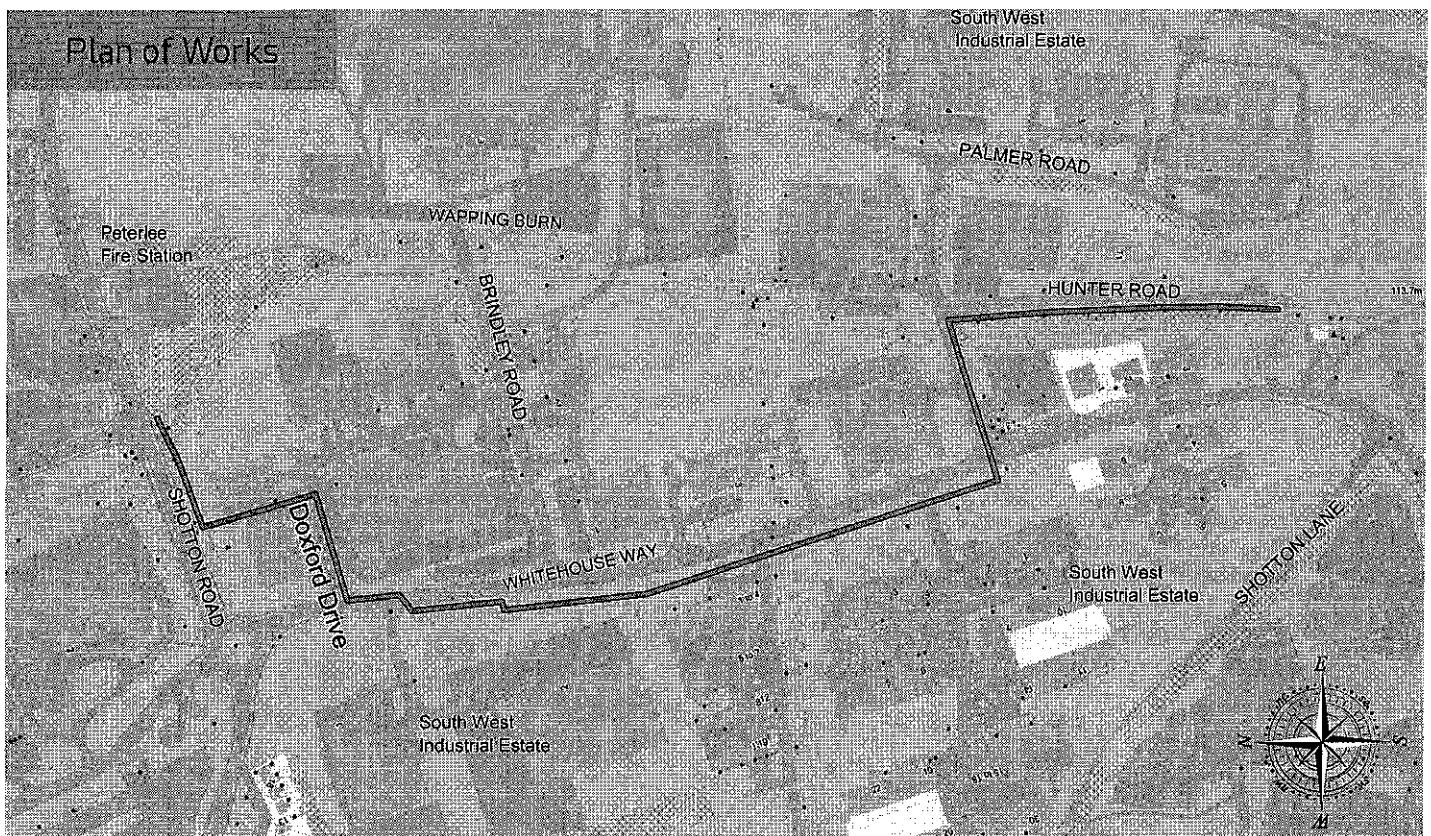
Plan of Works

The existing sewer pipe, which is in the proximity of Wapping Burn watercourse, will be replaced with 1,250 metres of new sewer pipe installed at Hunter Road, Swan Road, Whitehouse Way and Doxford Drive. This new sewer pipe will reconnect into the existing sewer to the west of Peterlee Fire Station.

Northumbrian Water are working with communities to proactively manage flood and pollution risk. They are committed to providing a high quality service and have identified an opportunity to improve their sewer network to reduce the risk of pollution events from the rising main which runs in close proximity to the Wapping Burn water course. Esh-MWH, working in partnership with Northumbrian Water, are installing 1250m metres of new 525mm diameter sewer along Hunter Way, Swan Road, Whitehouse Way, reconnecting into the existing main to the west of the Fire Station.

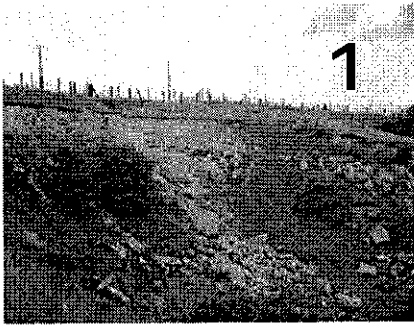
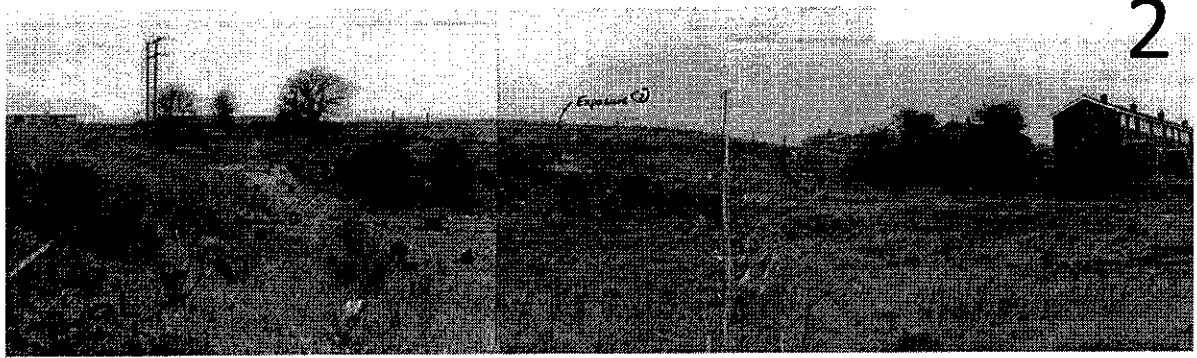
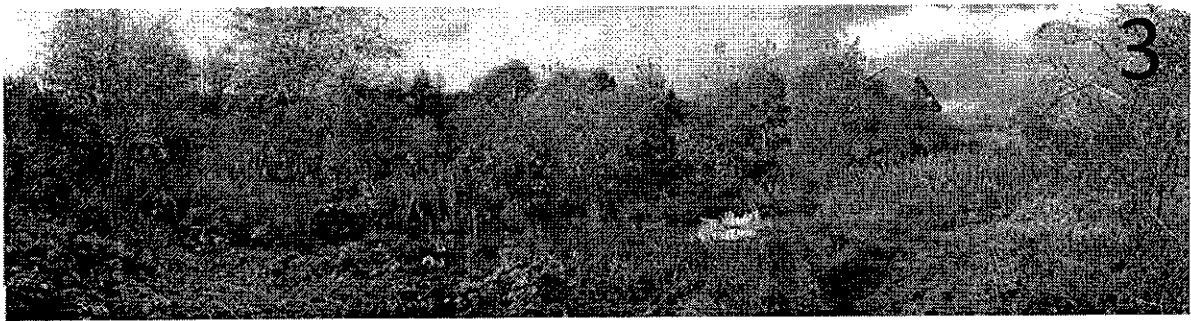
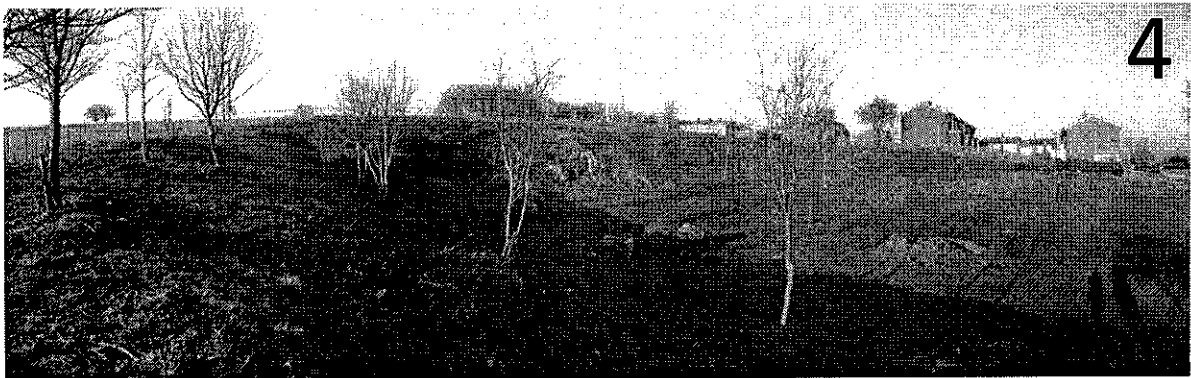
Figure 2 Photographs of the quarry through time:

The quarry face to the west of the quarry remained intact as can be seen in a photograph of 1966 (Figure 2.1), although it is not clear from the photograph whether the reservoir was still in place then.

1. Archive photo from 1966
2. Natural England (formerly English Nature) survey photo, probably 1992
3. The quarry in November 2016
4. The quarry in December 2016 following clearance of major vegetation and shrubs

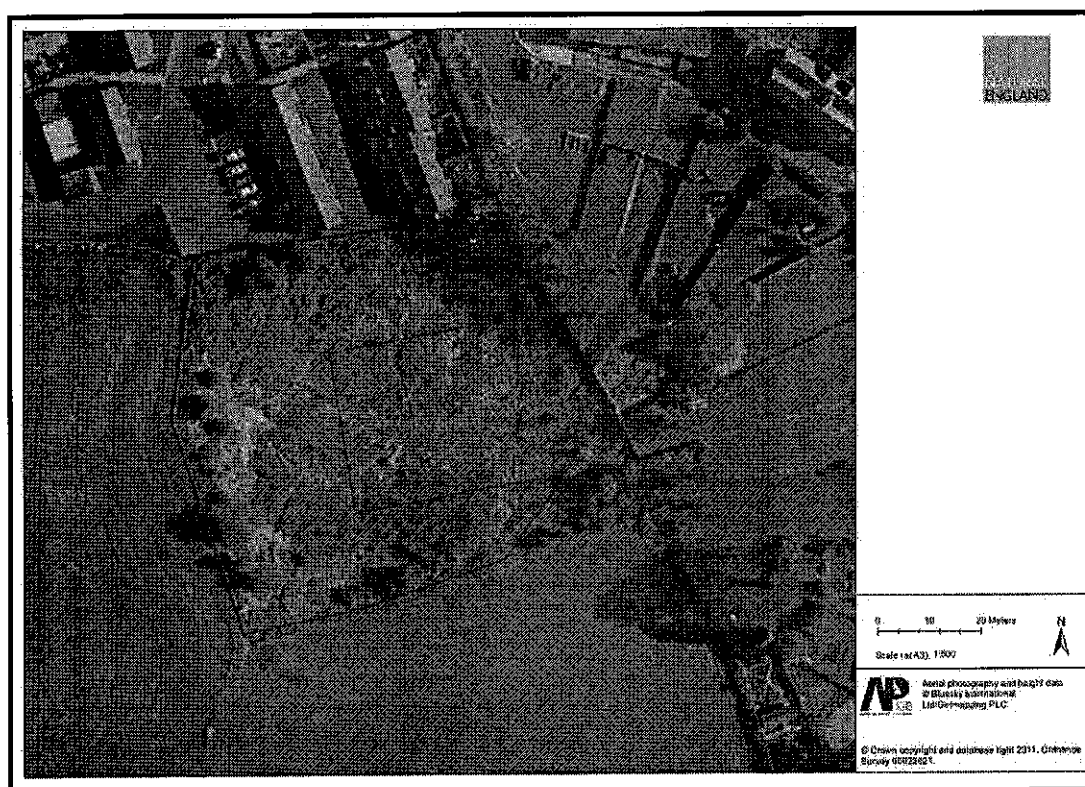
The site, SSSI boundary in red on Figure 3, is currently in 'unfavourable, declining' condition due to scrub encroachment (Personal communication from Tom Charman, Natural England, November 2016).

Figure 3 Yoden Village Quarry SSSI boundary (in red). Image courtesy of Natural England

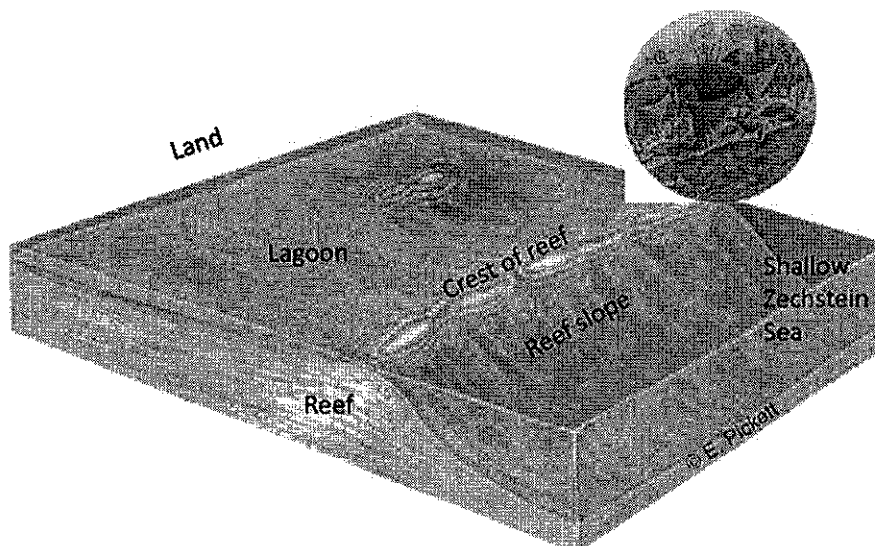
Figure 5 Schematic Cross-section through the reef

As the sea deepened limy muds started to build up on the sea floor. These would eventually harden to become the layered rocks known as the Magnesian Limestone. In time a remarkable barrier reef began to develop between the open waters of the Zechstein Sea to the east and a wide shallow lagoon to the west. The reef formed an almost continuous linear feature up to about 800m wide and at least 32km long. It was probably broadly similar in structure to the Great Barrier Reef in Australia and like modern barrier reefs it was flat-topped, with the reef top at or just below sea level. Beyond the lagoon was the coastline, probably about 30km to the west, where the eastern edge of the North Pennines is today. In the lagoon, fine limy sediments accumulated, similar to those found today in shallow tropical seas like those around the Bahamas. By contrast, the eastern, seaward, side of the reef dropped away steeply into deeper water. Here a thick scree of blocks and rubble, that had tumbled off the reef built up on this steep slope (Figure 5).

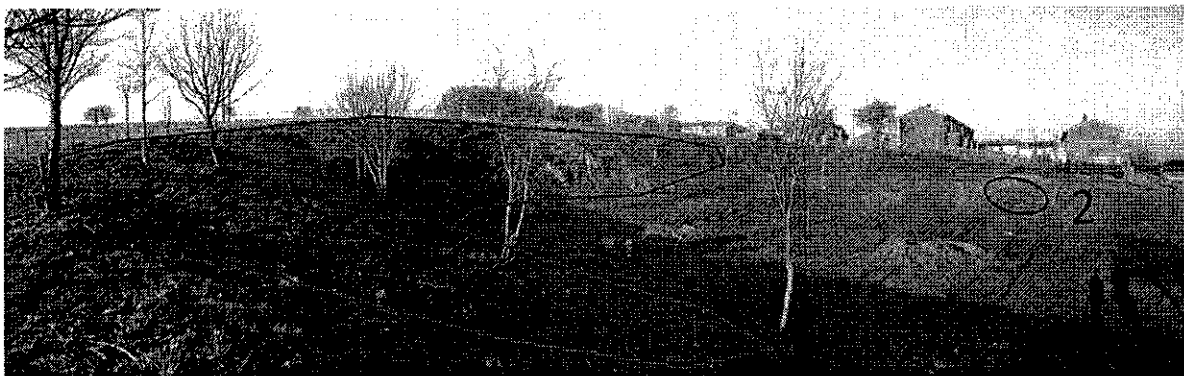
Figure 7 Yoden Village quarry in December 2016

As can be seen in Figure 6, the eastern (seaward) edge of the reef was situated where Yoden Village Quarry is today. Consequently, when designated, the rocks of the quarry exposed the top and edge of the reef (1 on Figures 7 and 8) and also the junction between the reef edge and overlying rocks (2 on Figures 7 and 8).

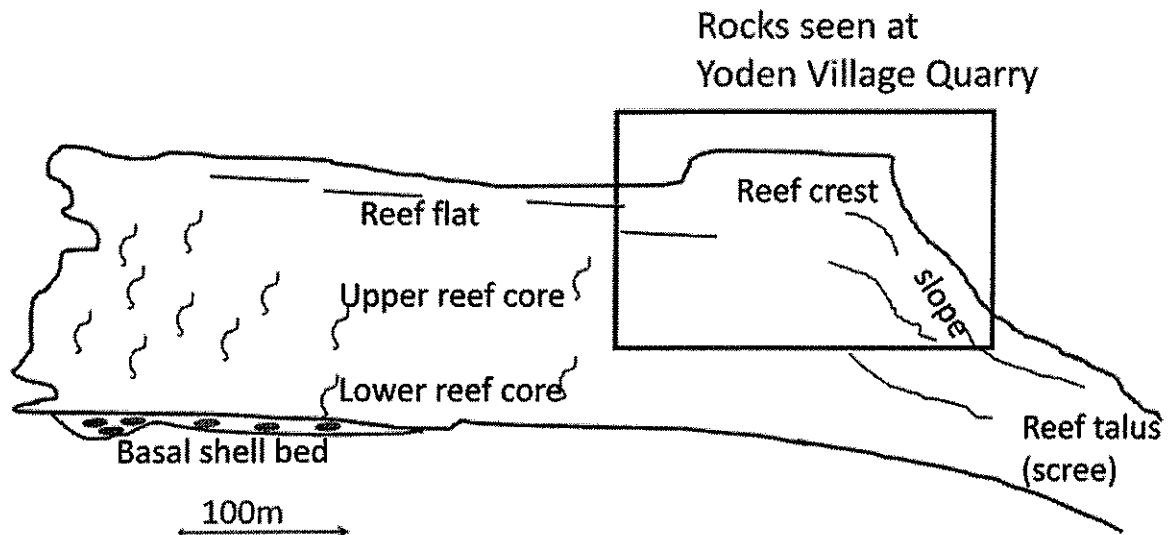
The quarry is the best place that the rocks of the transition from the horizontal reef crest to the near vertical, upper reef-slope can be seen and examined. The reef crest is characterized by a sharp change from gently-dipping, mainly thin-bedded dolomite of the reef flat to thicker-bedded, steeply dipping dolomite of the upper reef slope (Figures 9 and 10).

Figure 9 Diagrammatic cross-section of the Permian Reef

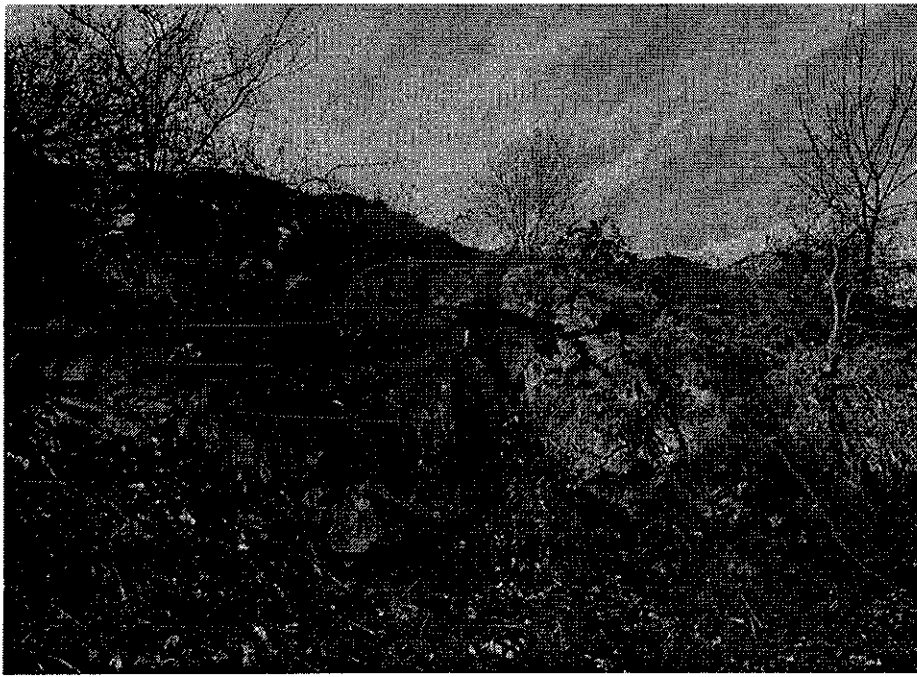
Figure 10 Rocks displaying the transition from the reef crest to the core in the quarry. Photo taken December 2016

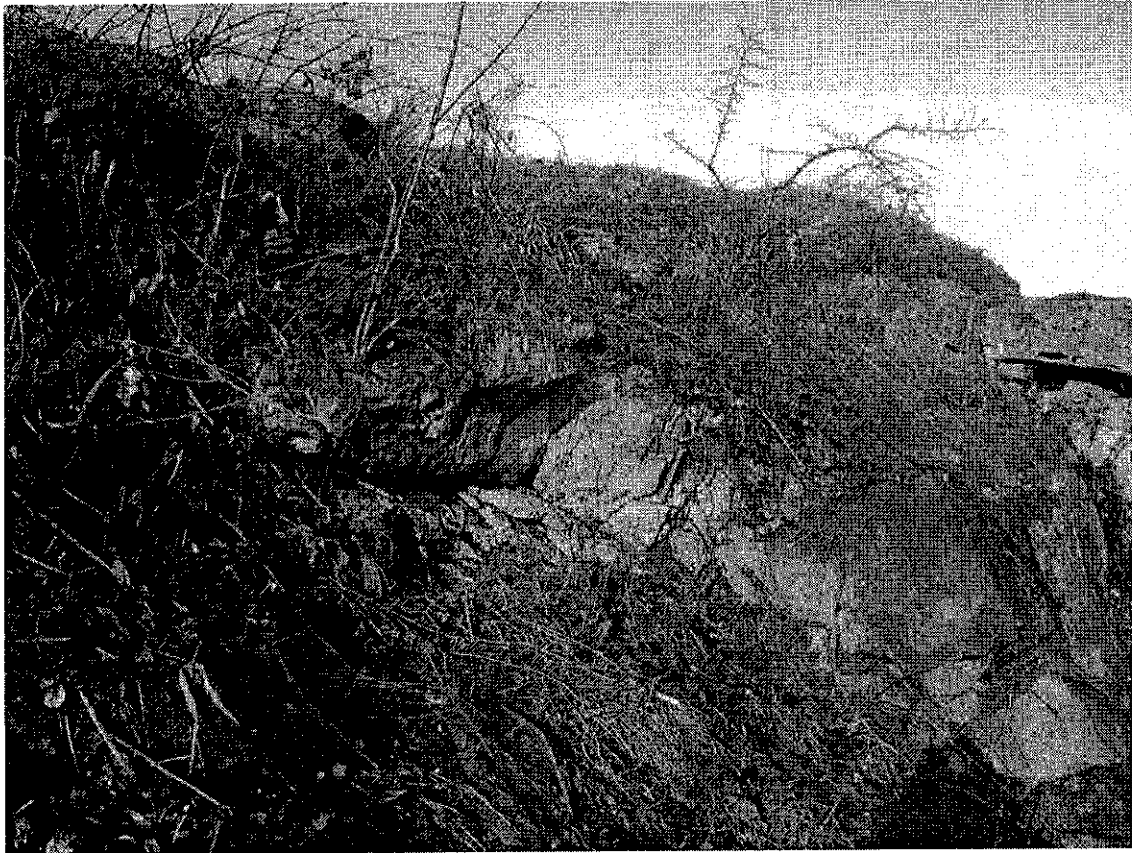
Figure 13 Invasive vegetation obscuring detail on main face

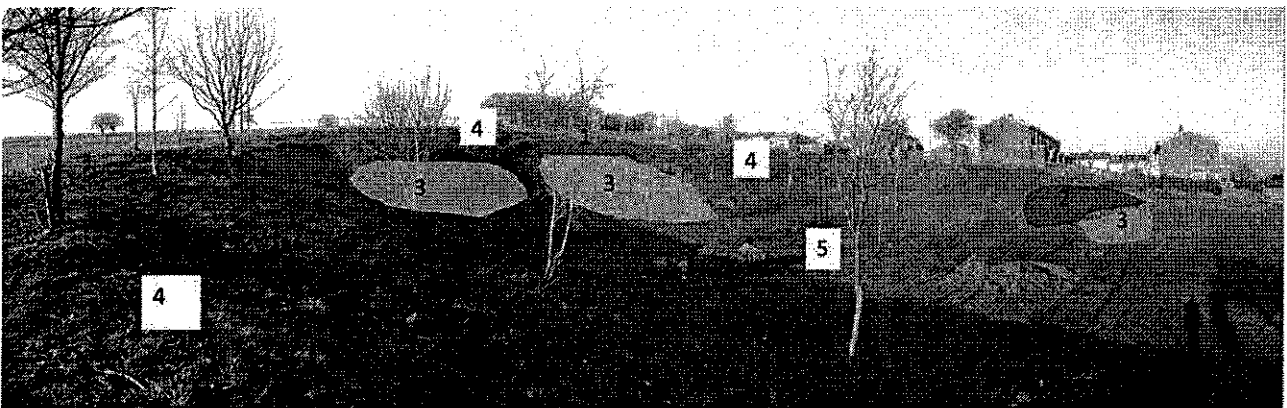
5. Quarry floor area: probably infilled by National Coal Board at closure of reservoir using waste material imported onto the site therefore unlikely to have any geological or ecological interest. Monitor vegetation regrowth in 2017 and manage thereafter as required to keep vegetation under control.

Review areas 1 and 2. Consider what management appropriate (consider planting to enhance Magnesian Limestone Grassland if present e.g. with yellow rattle)

Figure 14 Sketch diagram of proposed vegetation management areas.
